ControlLogix Controllers, Revision 16

ControlLogix Controller Catalog Numbers

This publication describes enhancements and anomalies (known and corrected) for ControlLogix controllers, revision 16.

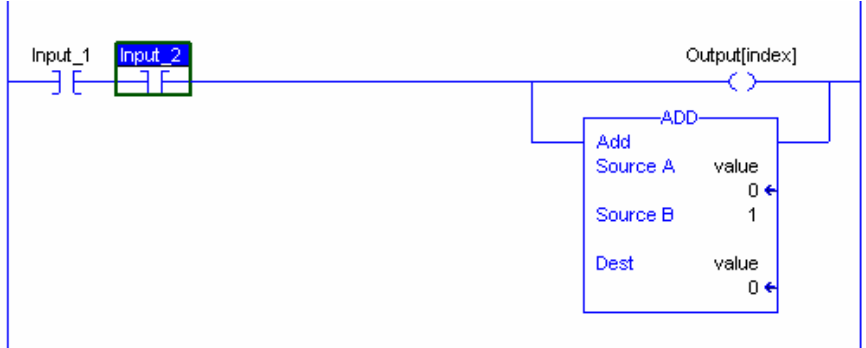
Cat. No.	Firmware Revision	Description
1756-L55Mxx, 1756-L61, 1756-L61S, 1756-L62, 1756-L62S, 1756-L63, and 1756-L64	16.022	<p>Fault handlers can be defined at the controller and program scope levels. These fault handlers are typically used to handle major recoverable faults that can occur during runtime execution of an application due to programming errors. A typical example of this would be handling indirect addressing that has gone out of range; <code>MyTag[index]</code>, where <code>index</code> is larger than the size of the array.</p> <p>Faults can also be handled by the controller during pre-scan of the controller program on the transition to Run mode. Again, for example, the handling of indirect addressing that has gone out of range.</p> <p>There is an anomaly when these methods attempt to handle a fault.</p> <p>These are the possible ways the anomaly can manifest itself:</p> <ul style="list-style-type: none"> • The controller will experience a major non-recoverable fault. I/O goes to their configured safe state, and the user application is cleared from memory. At this point, a Code 1 Type 60 or 61 major recoverable fault will be logged in the controller. This requires you to redownload the application. • Tag data corruption. • Online saving or uploading failures. • Anomalous program execution. <p>For example, if a rung is being scanned false and there is an instruction that has false execution, the fault handler executes so the remainder of the rung will scan true. In the example below, the OTE instruction has an index out of range. After returning from the fault handler, the ADD instruction will execute, even though the rung input conditions are false.</p>

<p>Lgx00106481, Lgx00107423, Lgx00100766, Lgx00106478</p>
